TS-PIC-92135
December 1992

Site Analysis
North Bronson Industrial Area
Bronson, Michigan

by
David B. Riccio, Imagery Analyst
The Bionetics Corporation
Warrenton, Virginia 22186

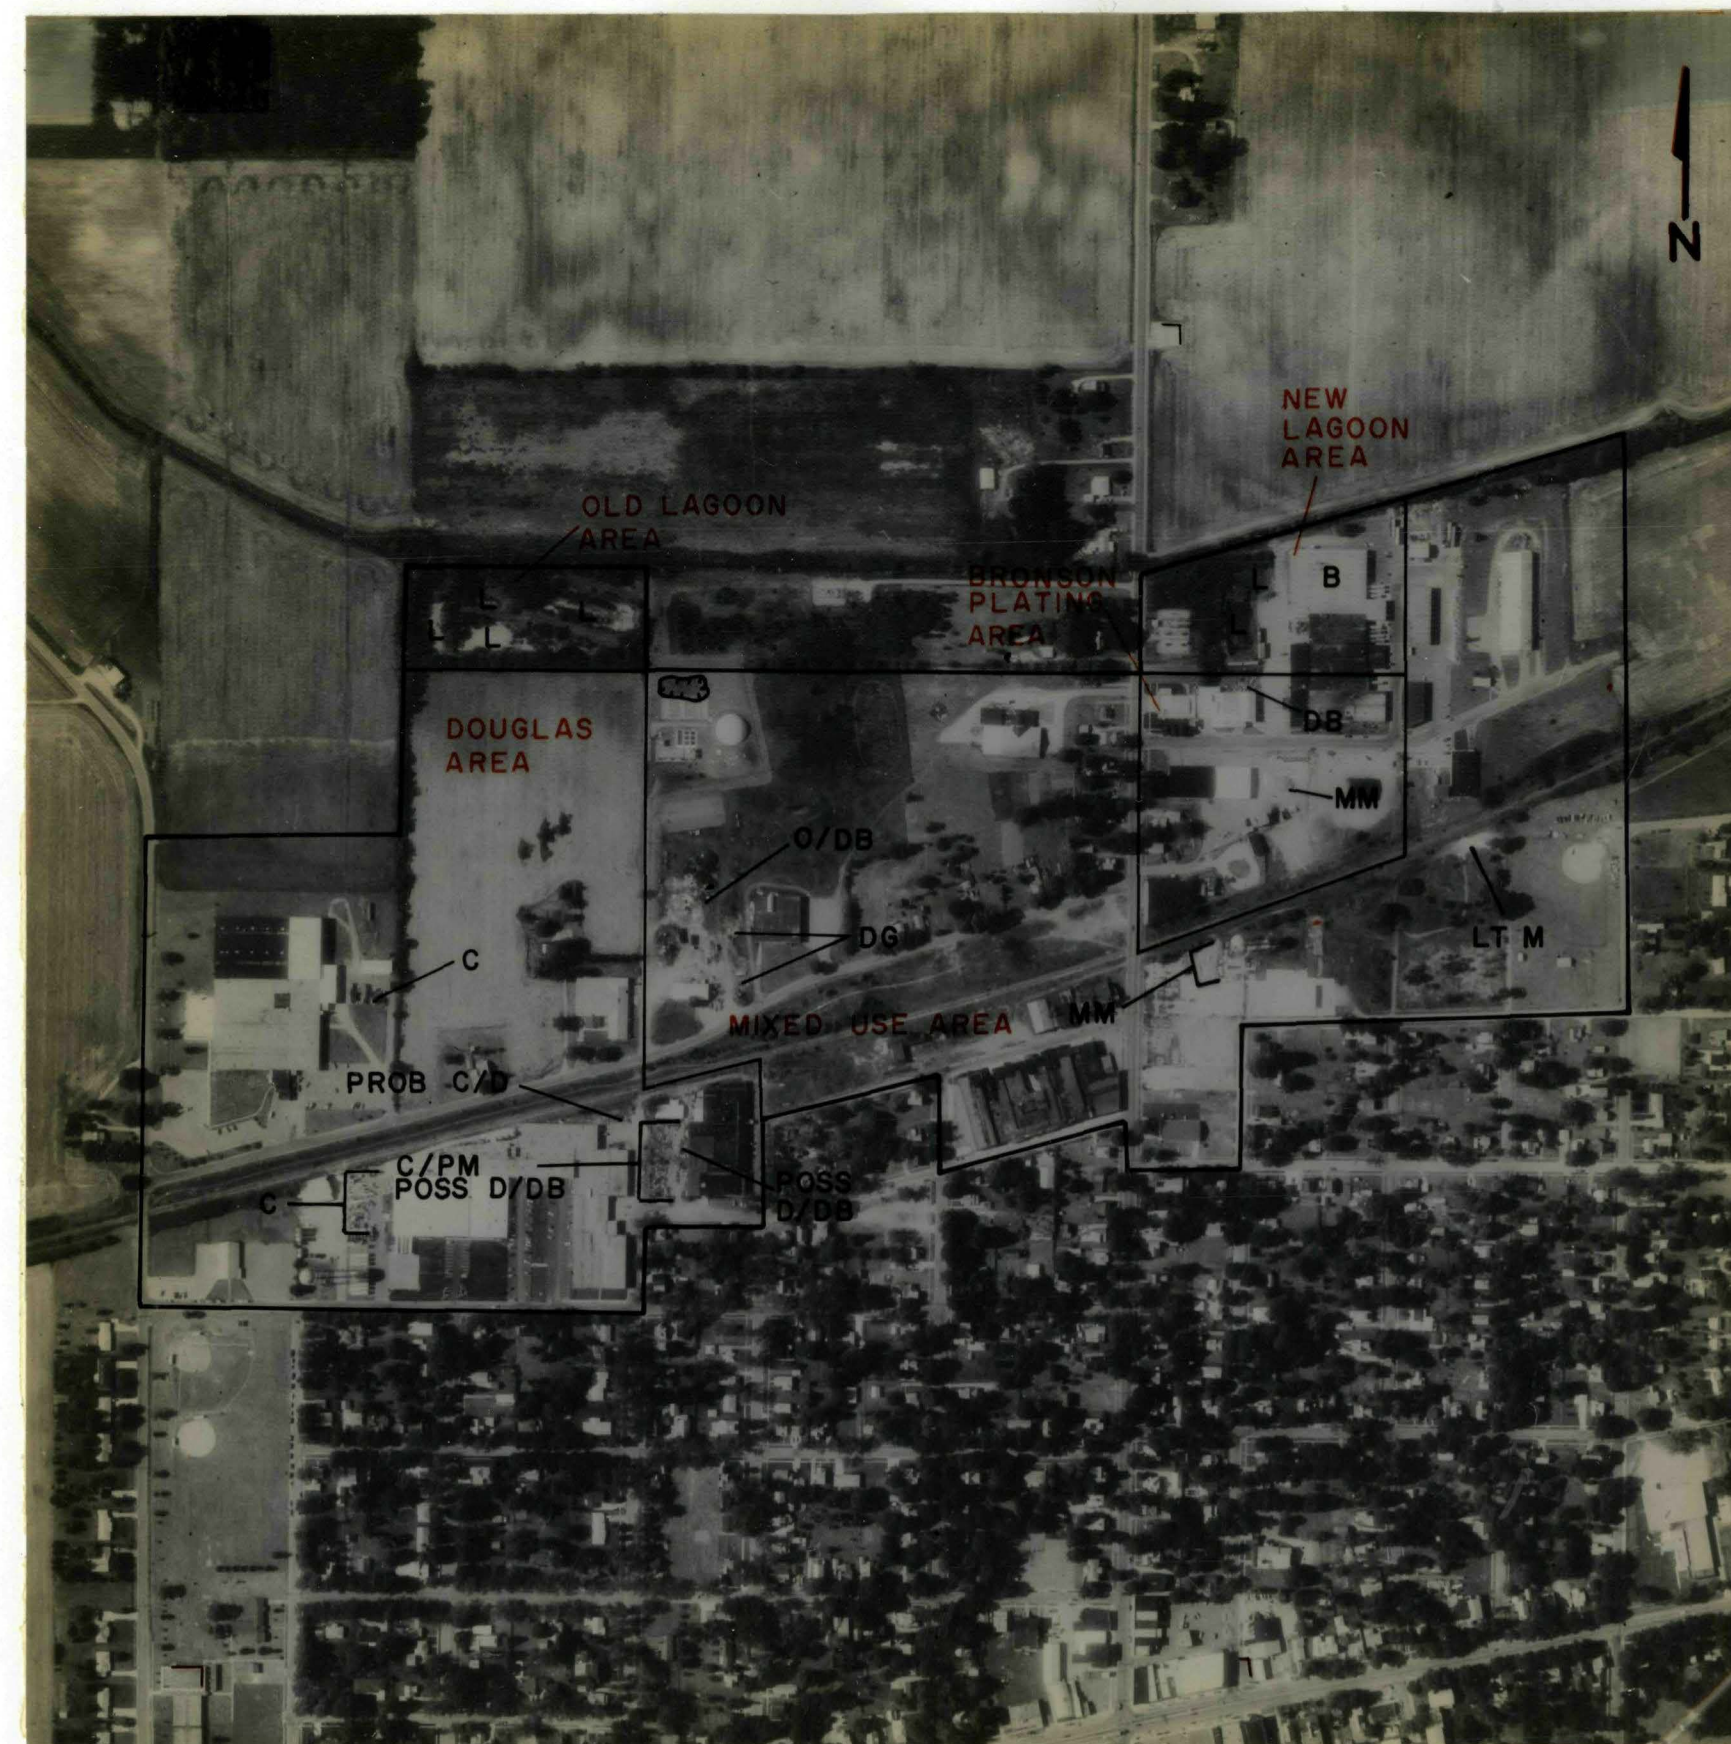
FIGURE 9
N. BRONSON IND.
AREA

Containers are noted east of the building in the west central portion of the site where debris was seen in 1967.

Neatly piled probable containers and drums are noted south of the railroad. Southeast of the aforementioned probable containers and drums is a fenced (not annotated) area of haphazardly placed containers and piping materials, as well as possible drums and debris. Possible drums/debris are also noted immediately adjacent to the building here.

A concentration of objects and debris, and two areas of disturbed ground are noted near the western boundary of the Mixed Use Area. Disturbed ground and access roads seen in 1978 are not present this year. Mounded material is noted south of the Bronson Plating Area.

Light-toned material is evident southeast of the Bronson Plating Area. Light-toned materials and possible light-toned liquid have been seen at this location since 1950, and a possible impoundment was noted here in 1938.

Debris and mounded material are noted within the area. The mounded material is in the center of an otherwise cleared area, and is similar in appearance to mounded material noted elsewhere on the site.
